# Impact of Electricity Utility Structures on Raptors

# Raptor Mortality on Powerlines in South Africa

Chris S. van Rooyen

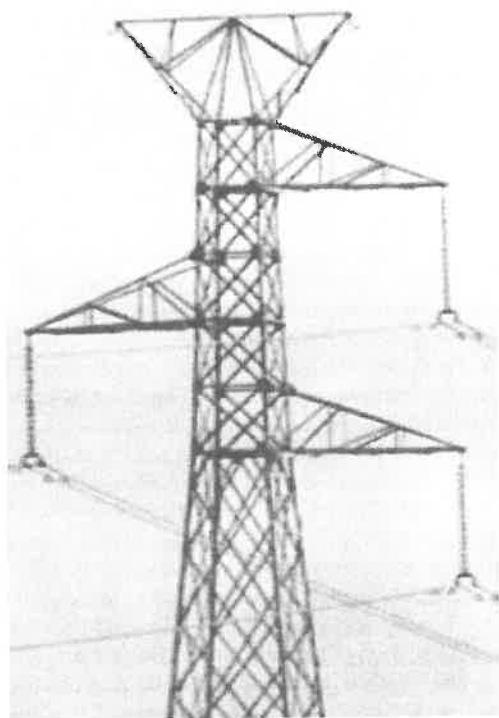
**Figure 1. Delta suspension structure**

On the Delta suspension structure, birds are electrocuted presumably when they take off from or land on the lowest cross-arm. The vultures prefer to perch on the extreme end of the cross-arm, right above the string insulator (pers.obs.). Another possibility (believed widely by Eskom field staff) is that the birds often excrete before taking off, thus bridging the critical gap between conductor and cross-arm, and causing a phase to earth fault.

Various bird guards have been proposed to prevent the birds from perching above the insulator, but by preventing the bird from perching on the structure, the problem is simply transferred to the next structure. An attempt was made to accommodate the birds by fixing PVC spirals to the conductor around the insulator clamp to create a barrier to the wing-tips touching the conductor at the moment of landing (as was done with the 88 kV Kite constructions). Although this method initially rendered positive results, electrocutions were again reported from poles modified in this manner. A possible explanation might be that the spirals themselves become energised after a couple of years, and/or the fact the Cape Sparrows *Passer melanurus* have taken to nesting inside the spirals (pers.obs.), thereby seriously reducing their insulating effect. Steps are currently being taken to physically modify the design of these poles in order to eliminate the electrocution problem.

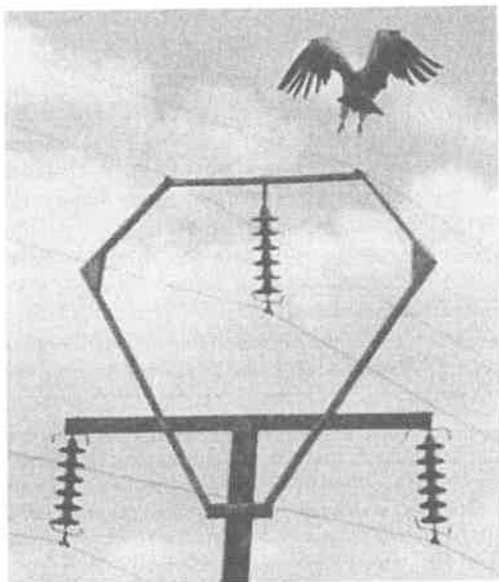
**Figure 2. Kite structure**

The problem of electrocutions on Kite-structures was thought to have been solved after they were fitted with perches and PVC spirals wrapped around the centre conductor clamp to form a "basket" to prevent birds from touching them.

However, investigations into continued electrocutions on Kite-structures thought to have been rendered safe in the manner described above, revealed that the problem had not been solved (Van Rooyen 1998).

A new approach was tried i.e. to stretch two inter-linked PVC spirals directly above the bottom cross-arm to form an obstacle, thereby effectively preventing the vultures from landing on the bottom cross-arm. This seems to have reduced the rate of electrocutions, but the problem has not been entirely solved<sup>6</sup>.

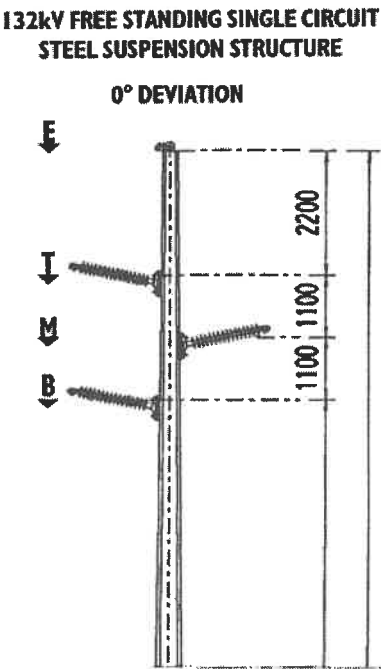
Figure 4. Steel suspension structure Type 259

A design that is becoming increasingly popular with Eskom for 88 kV and 132 kV feeders due to its relatively cheap construction, little impact on the physical environment, ease of construction and limited visual impact, is the new 259 series. These are single, earthed steel poles with three staggered insulators, each 1.5 metres in length. The areas through which many of these powerlines will run harbour populations of large scavenging birds such as Cape Griffons and African Whitebacked Vultures, and large eagles such as Martial and Black Eagles. These birds will almost certainly attempt to perch on the new poles, and specifically the insulators. In the process, the bird will most probably not be able to secure a firm foothold on the slippery insulator. Given the length of the insulator relative to the wingspan of these species, the chances of a phase to earth fault in the process are considerable, not only resulting in the electrocution of the bird, but also causing problems in the power supply.

The EWT through the Partnership expressed concern over the electrocution potential of this design. Eskom design engineers have undertaken that poles of this design will be fitted with a wooden perch fastened to the top of the pole as a standard feature in specific areas, to create perching space for birds, if so advised by the EWT.

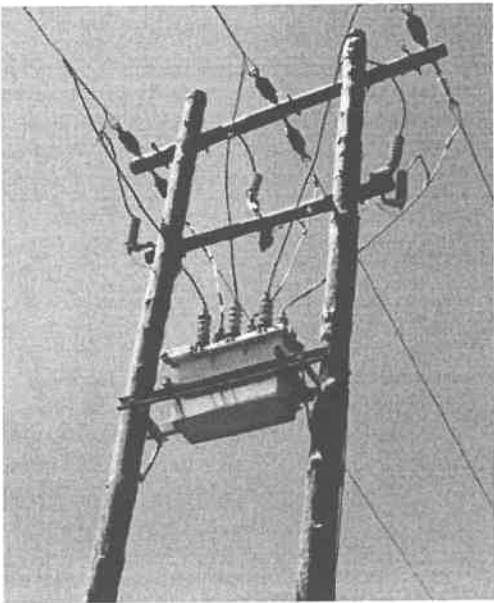
Figure 5. Terminal structure with pole mounted transformer

The next most common structures implicated in electrocutions (22.1%), are terminal structures. The lethal nature of terminal structures has been recognised elsewhere (Harness 1997), as well as in southern Africa (Smith 1992, Ledger *et al.* 1992).

These structures are particularly lethal because of the following reasons:

- Minimal phase to phase and phase to ground spacing between the energised components, particularly the bare jumper cables connecting transformers, protective switches and surge arrestors.

- Terminal structures often serve water pumps in remote, arid areas to provide surface water for livestock. Raptors are drawn to the water for drinking and bathing purposes, and get electrocuted on the terminal structure. This problem is likely to be aggravated by wet feathers.

- Virtually every farmyard in South Africa has one or two terminal structures. Barn Owls and Spotted Eagle Owls often frequent farm yards, presumably for the nesting opportunities in barns, and the large rodent populations often associated with farm yards. They use the terminal structures as convenient hunting perches with fatal consequences. Neither the Barn Owl nor the Spotted Eagle Owl is presently regarded as threatened in southern Africa, but the situation needs careful monitoring.

To render the terminal structures safe for raptors and other birds, suitable insulation is fitted to all the jumper leads above the cross-arm, and to the jumpers running to the transformer. Lightning arrestors are now fitted on the transformer rather than the cross-arm, eliminating the need for jumper leads on the top cross-arm. In several areas, the systematic modification of terminal structures to render them harmless for birds, have started. The process is however far from being completed and many thousands of these lethal structures still dot the landscape of South Africa.
